# **POTENTIAL ENVIRONMENTAL CONSTRAINTS & RESIDENTIAL AND COMMERCIAL DISPLACEMENTS PLATES**

### US 69 / LOOP 49 NORTH LINDALE RELIEVER ROUTE

CSJ: 0190-04-033  
SMITH COUNTY

### **PROJECT AREA PHOTOS**

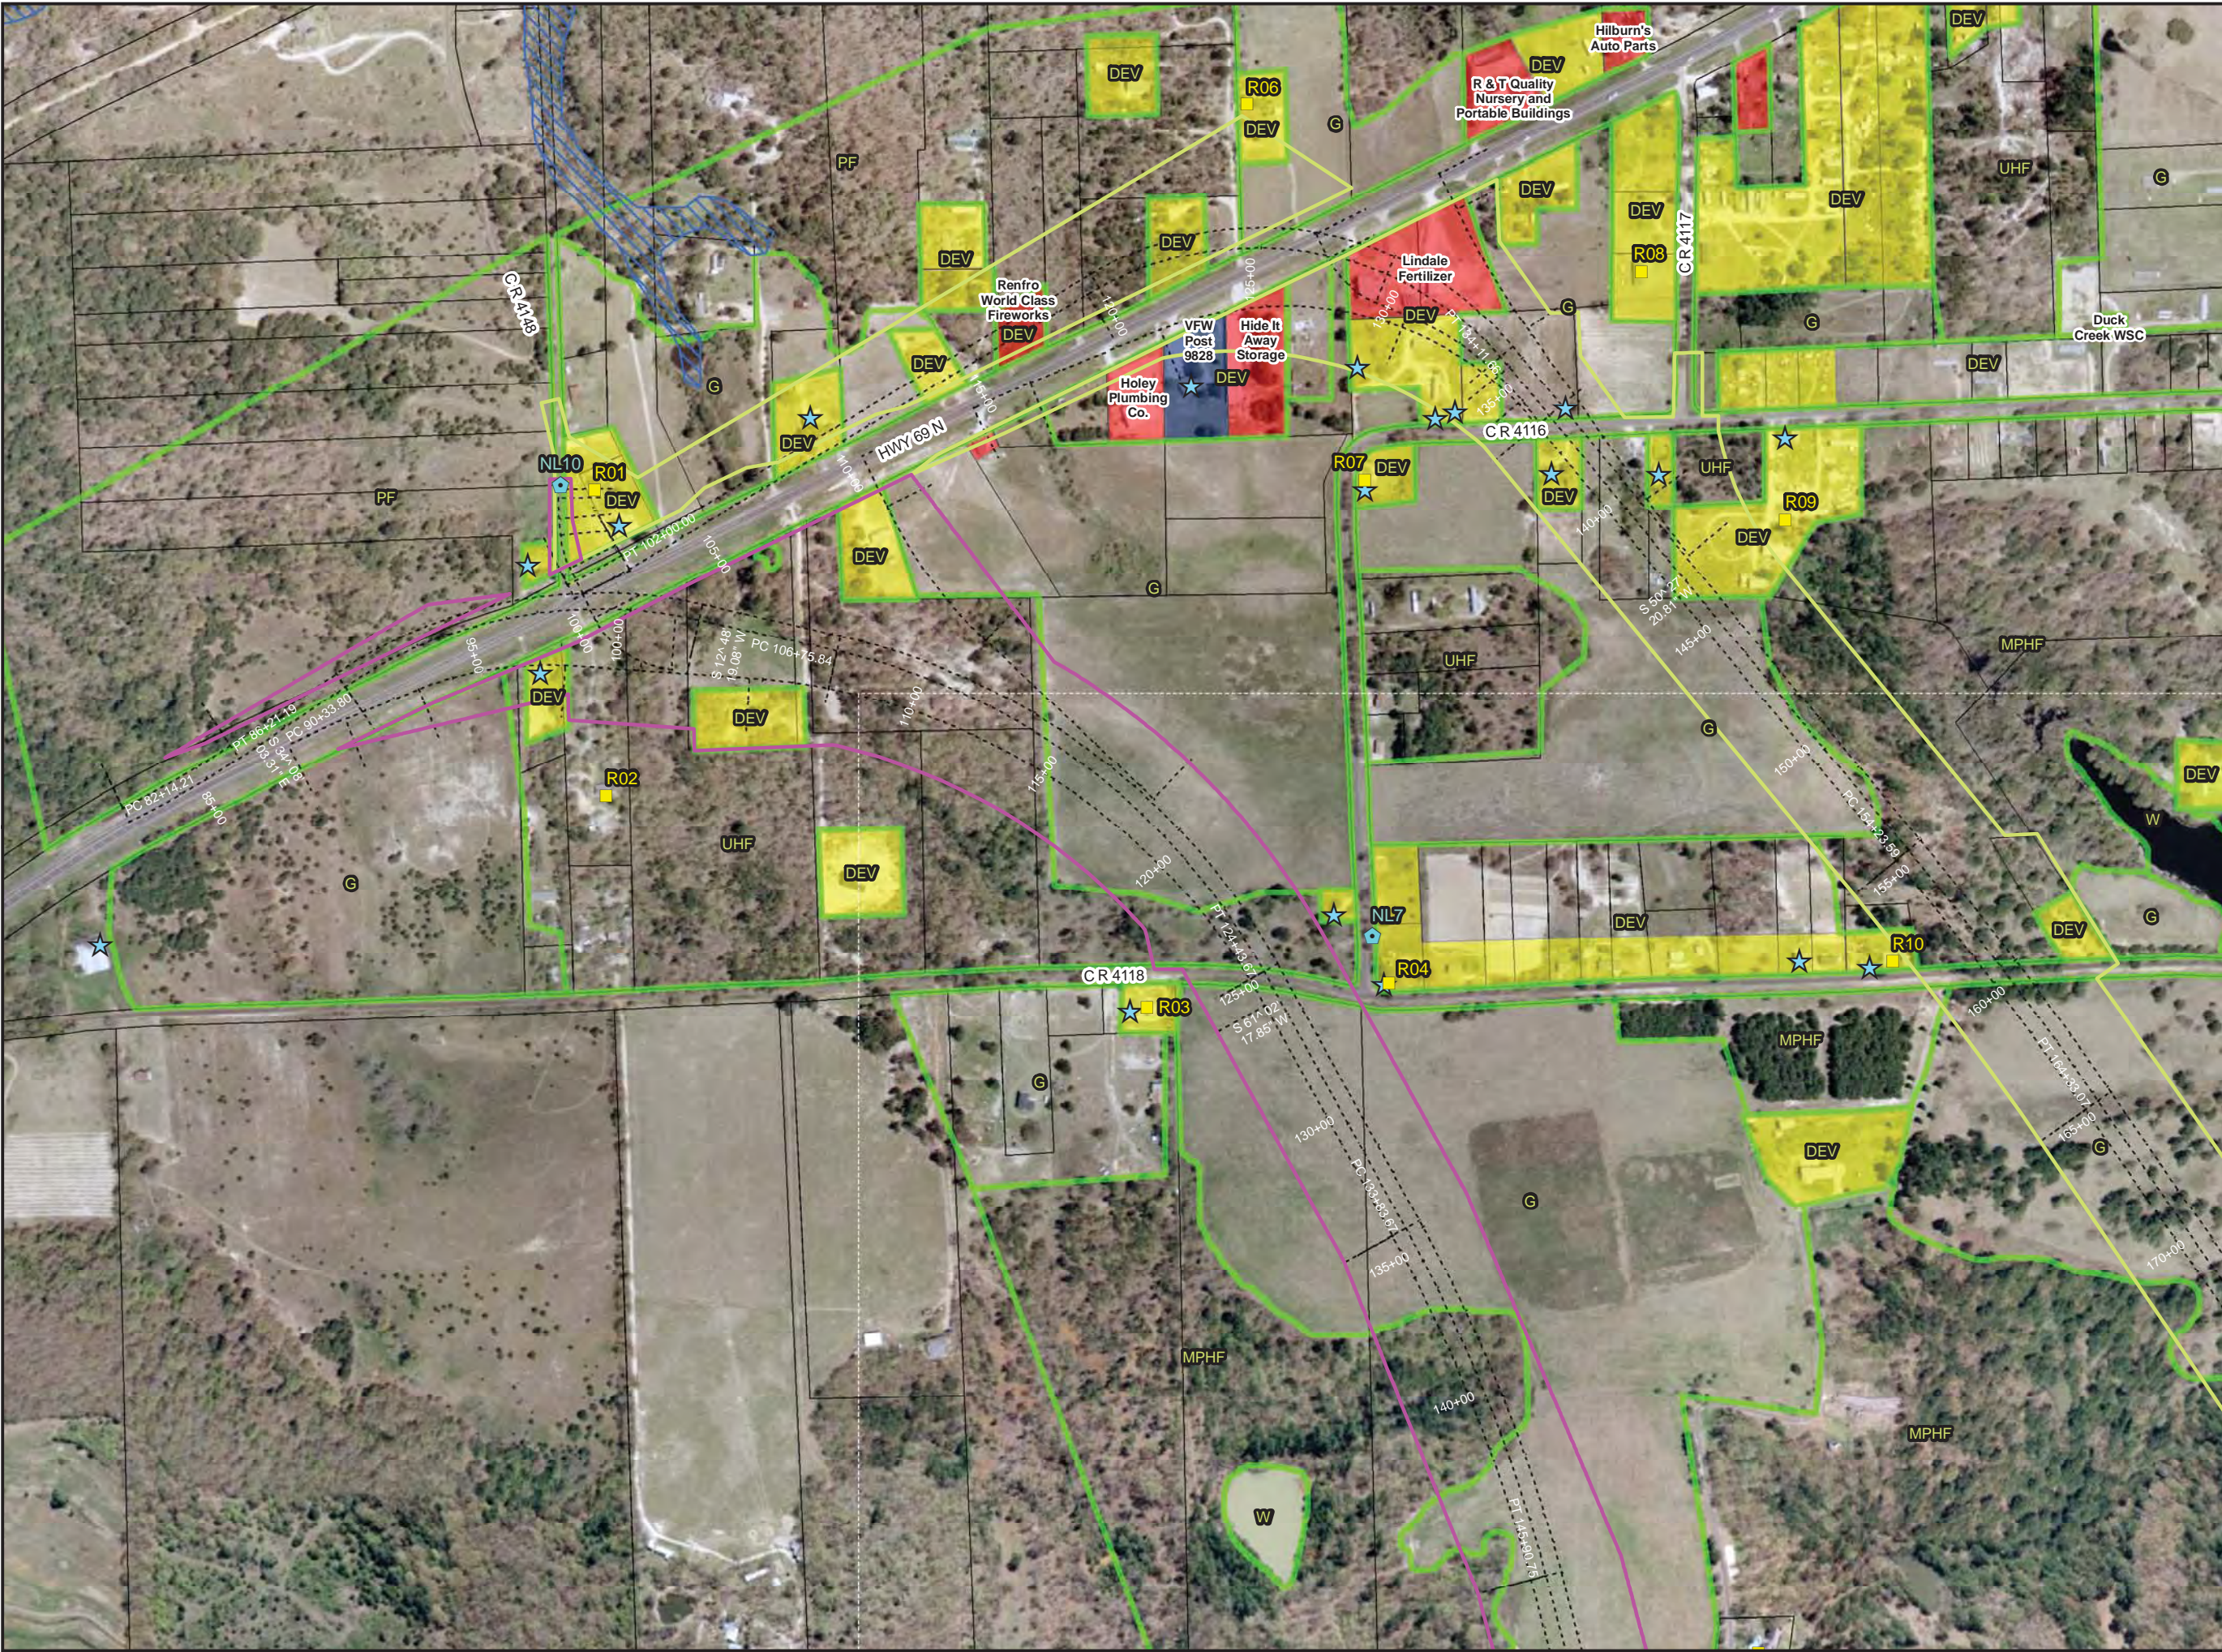
PLATE 1	APRIL 2013
---------	------------

### POTENTIAL ENVIRONMENTAL CONSTRAINTS

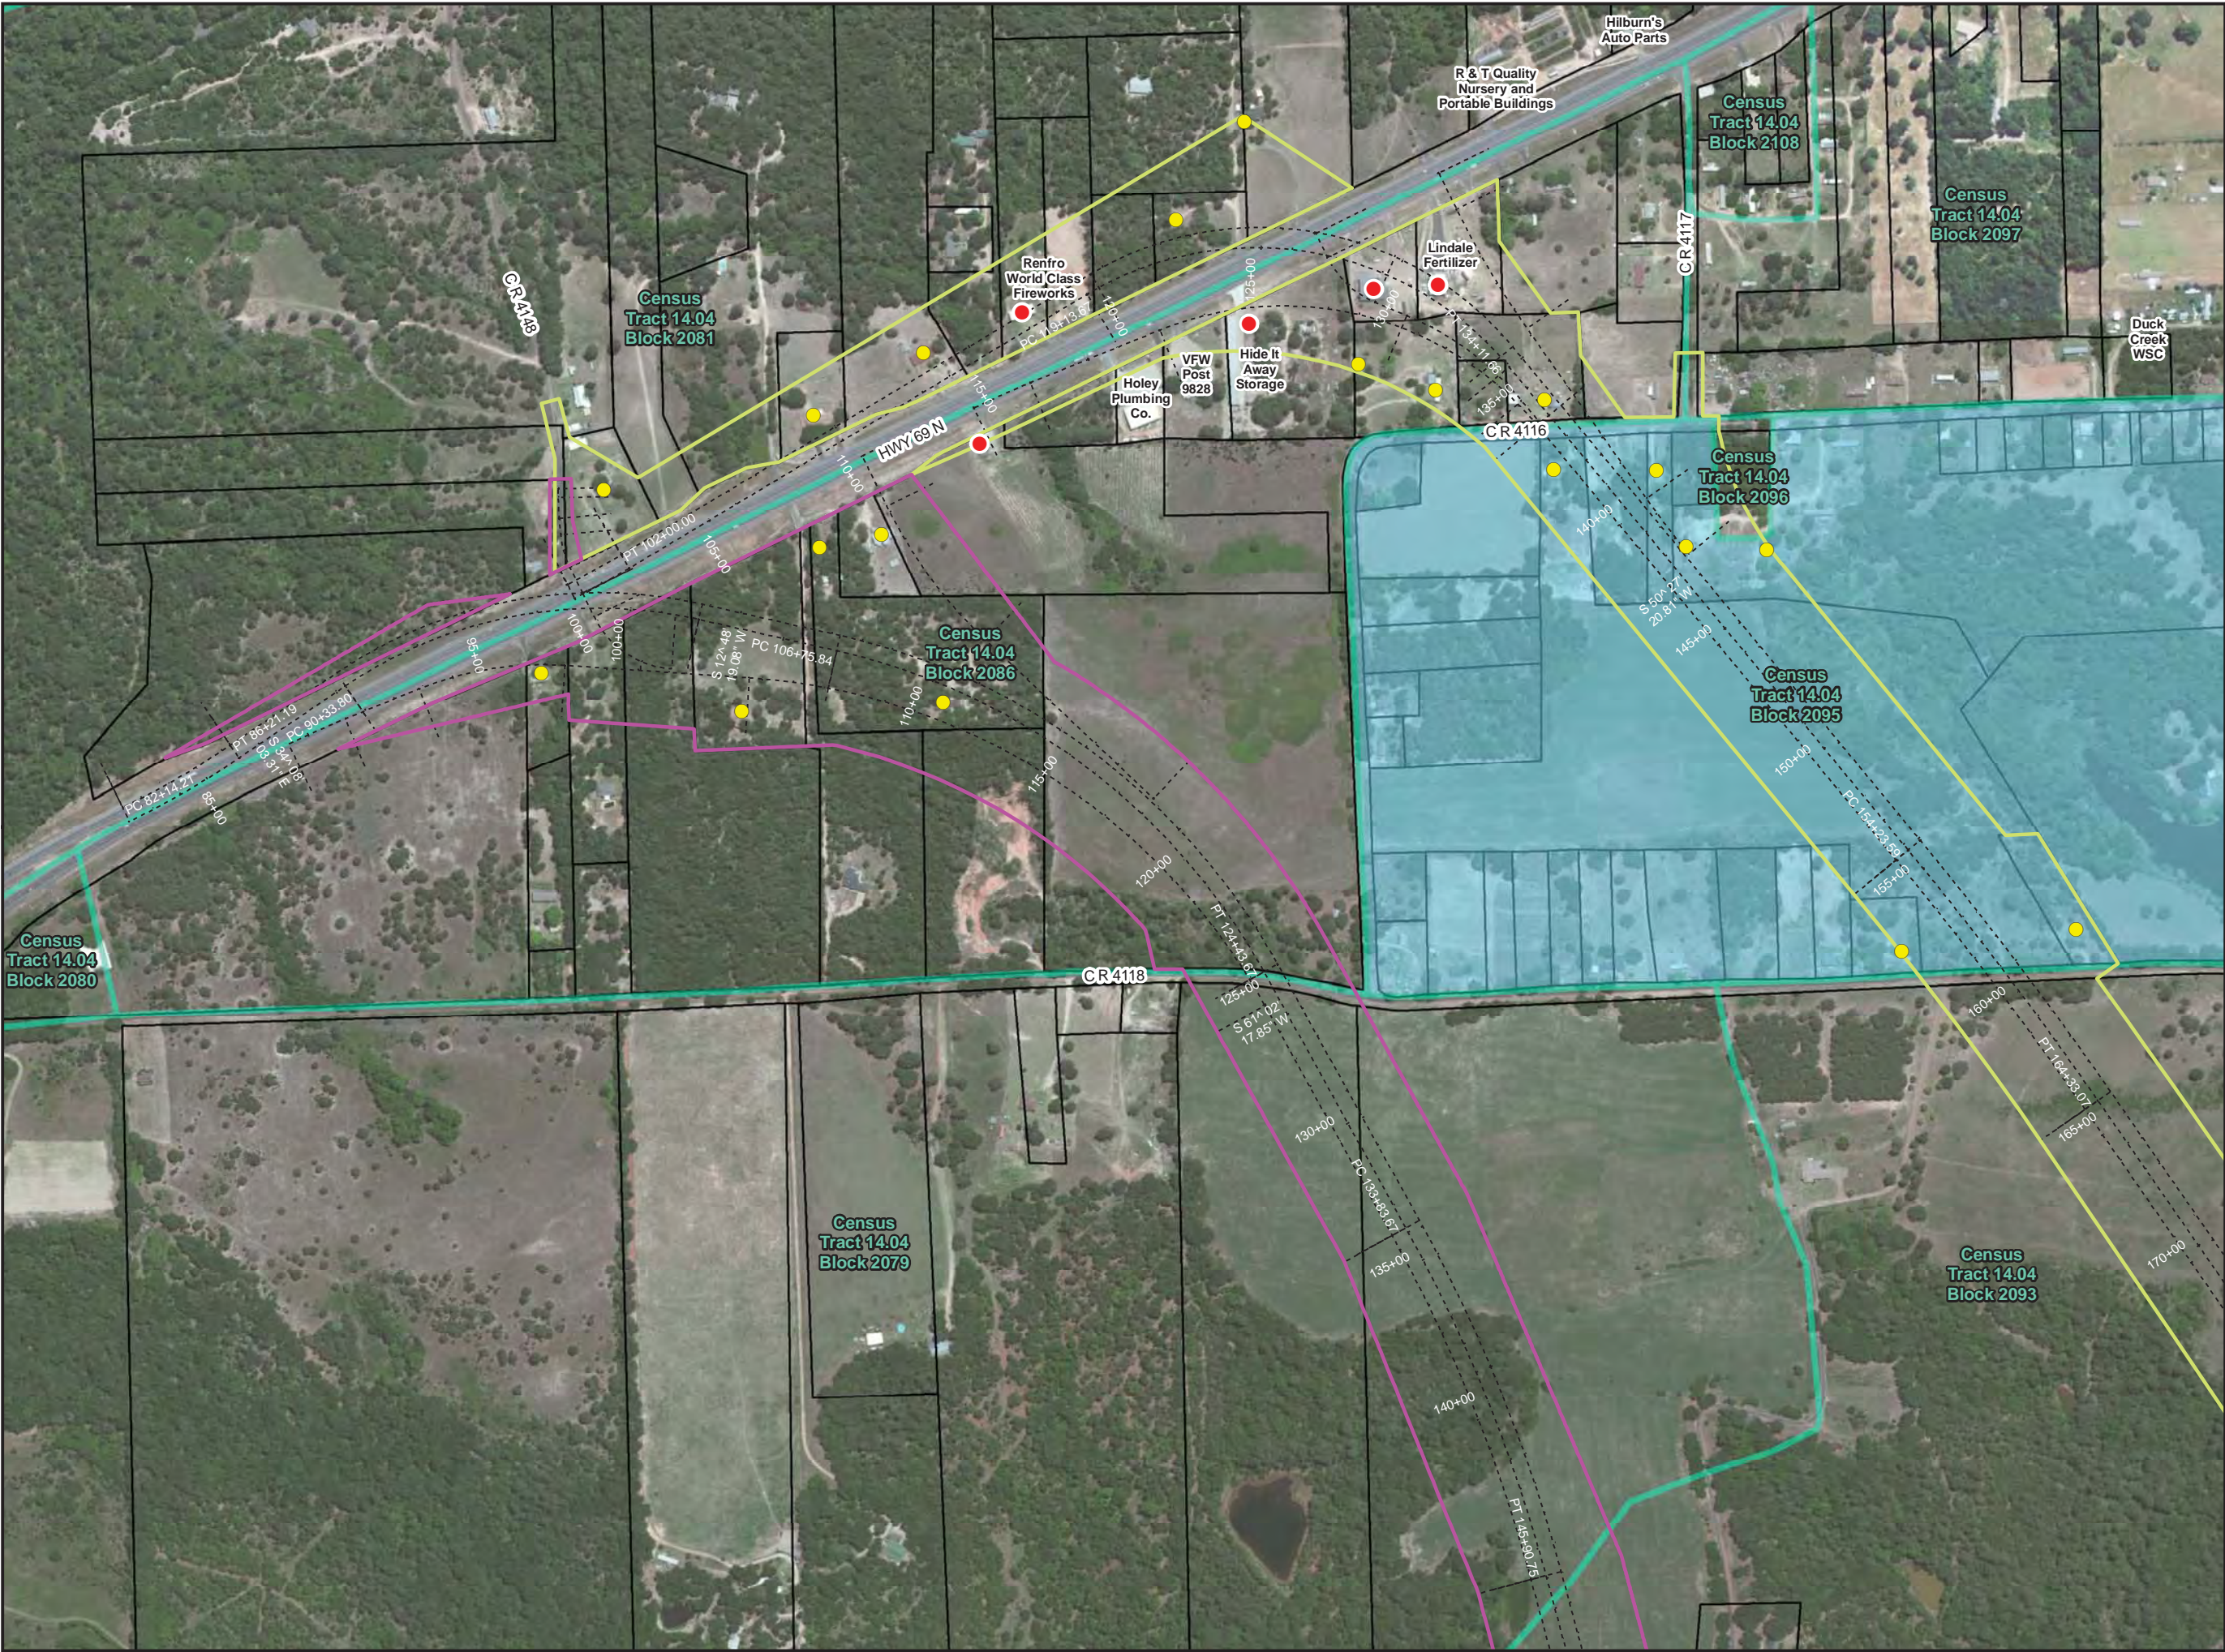
PLATE 1      APRIL 2013

**RESIDENTIAL AND COMMERCIAL  
DISPLACEMENTS**

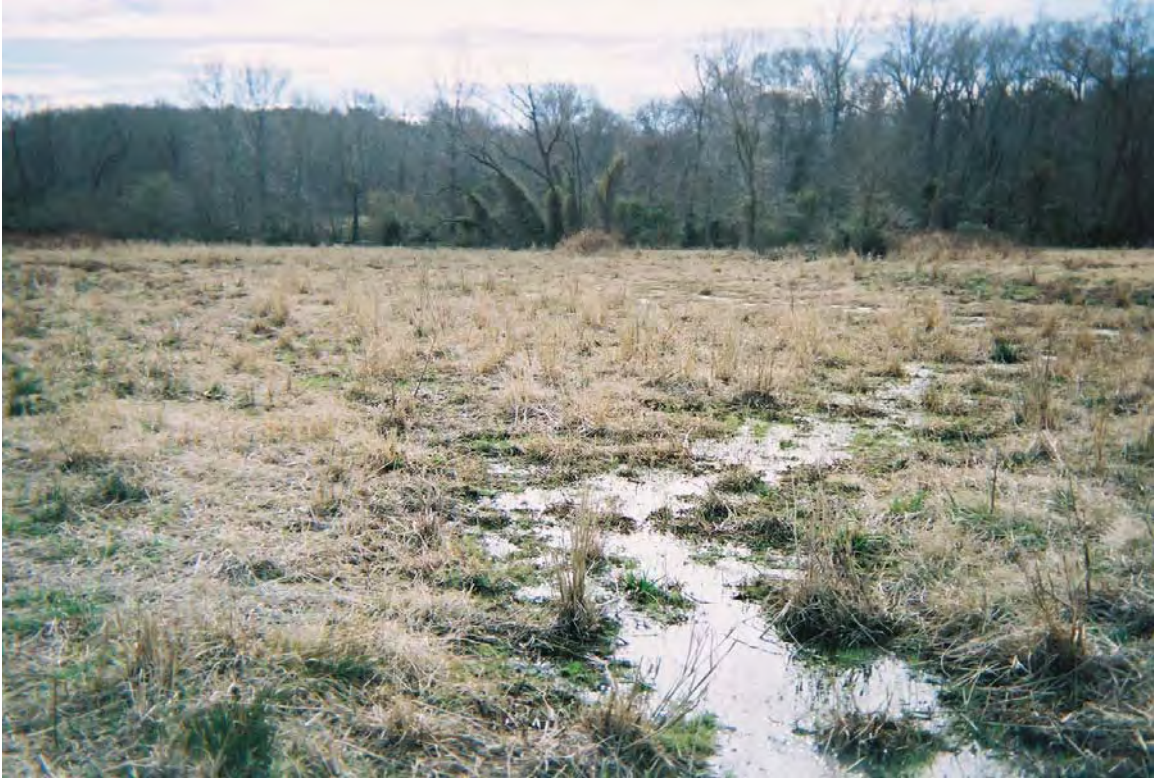
Wetland in floodplain south of Stevenson Branch, Alternative G.

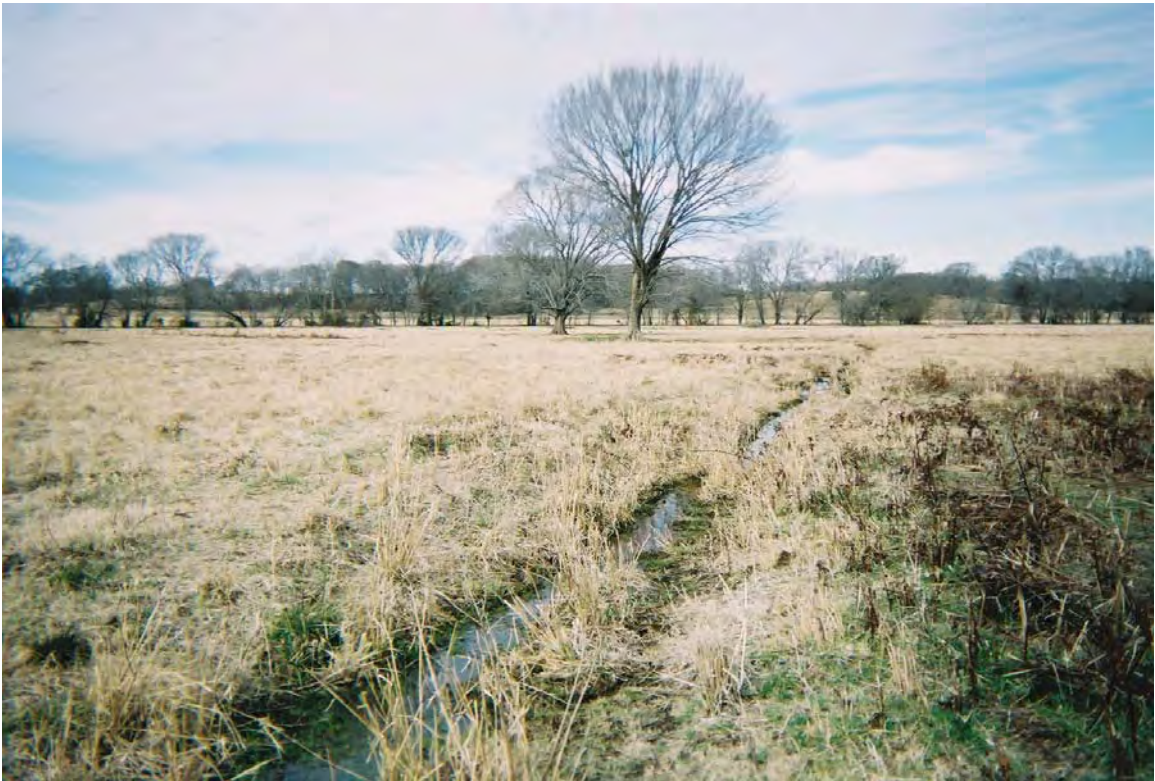
Man-made ditch through wetland in floodplain south of Stevenson Branch, Alternative G.

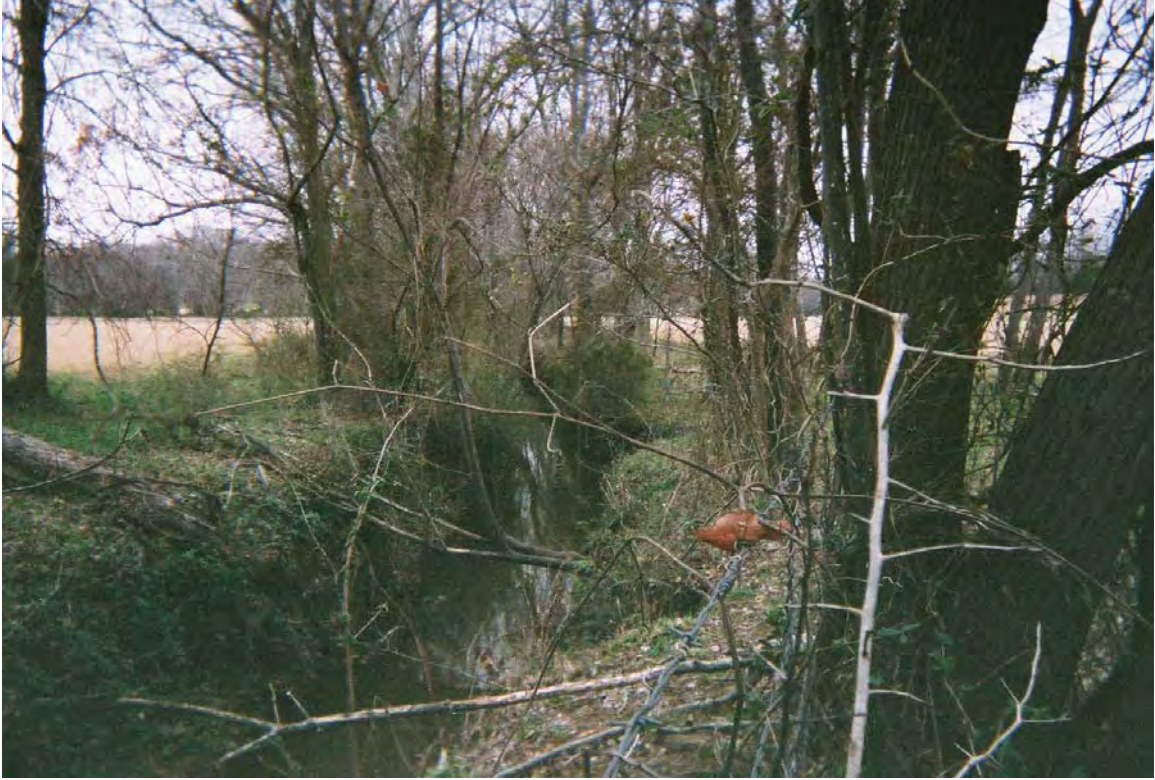
Stevenson Branch, Alternative G.

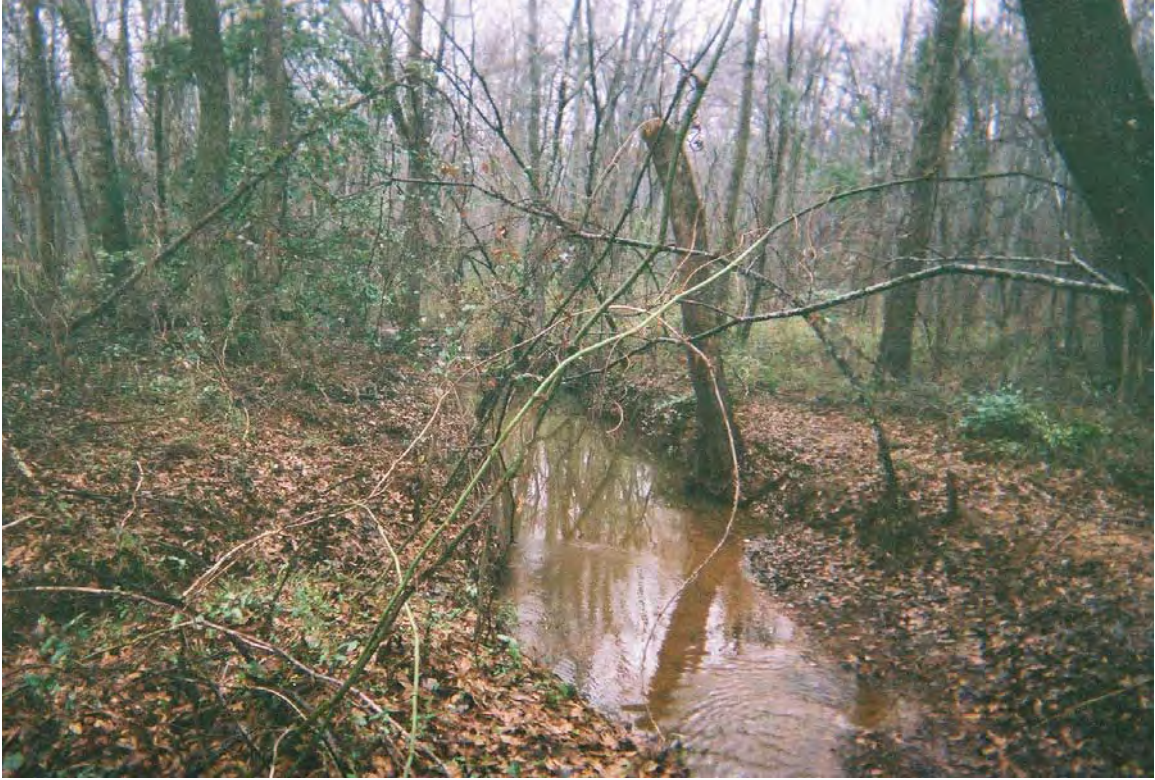
Stevenson Branch, Alternative D.

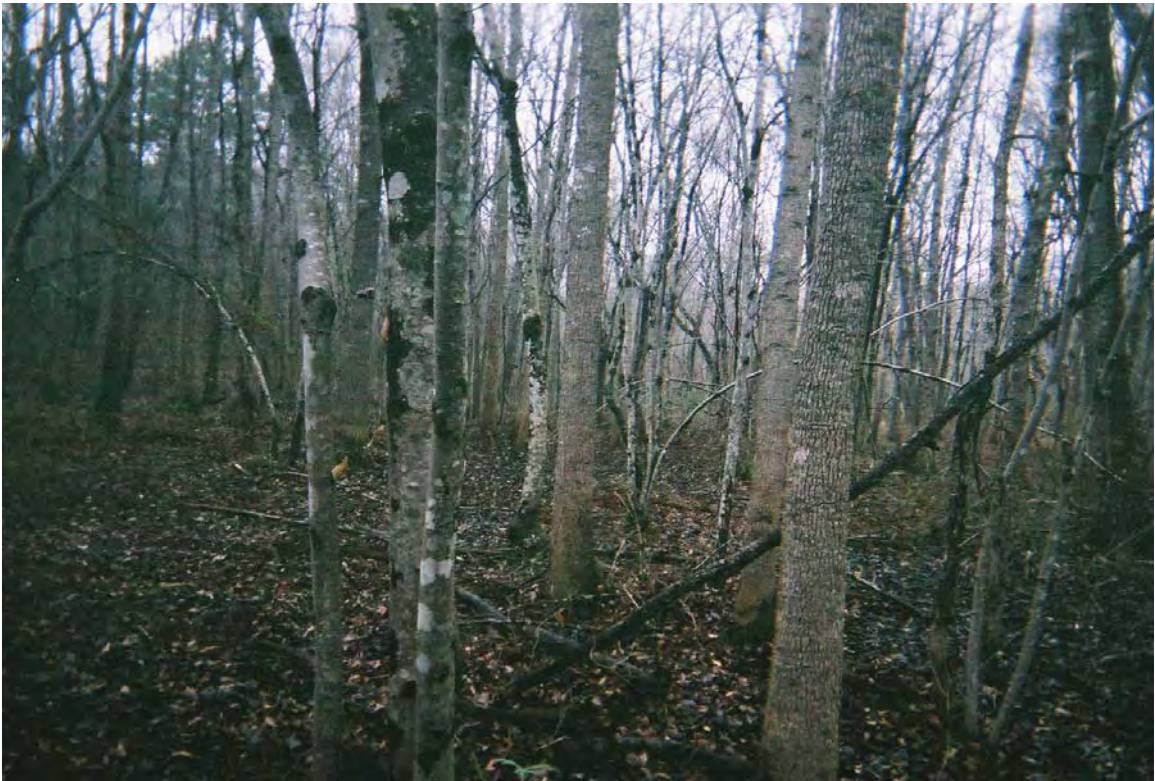
Wetland adjacent to Stevenson Branch, Alternative D.

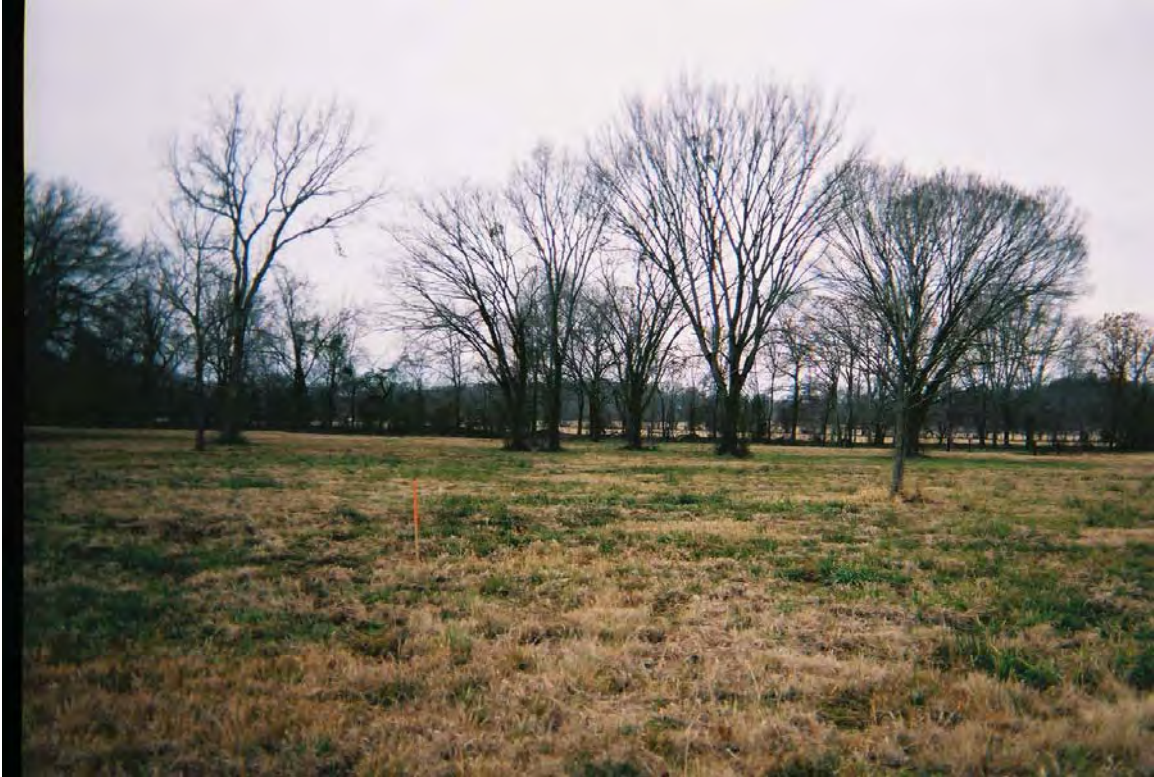
Wetland in floodplain north of Stevenson Branch, Alternative G.

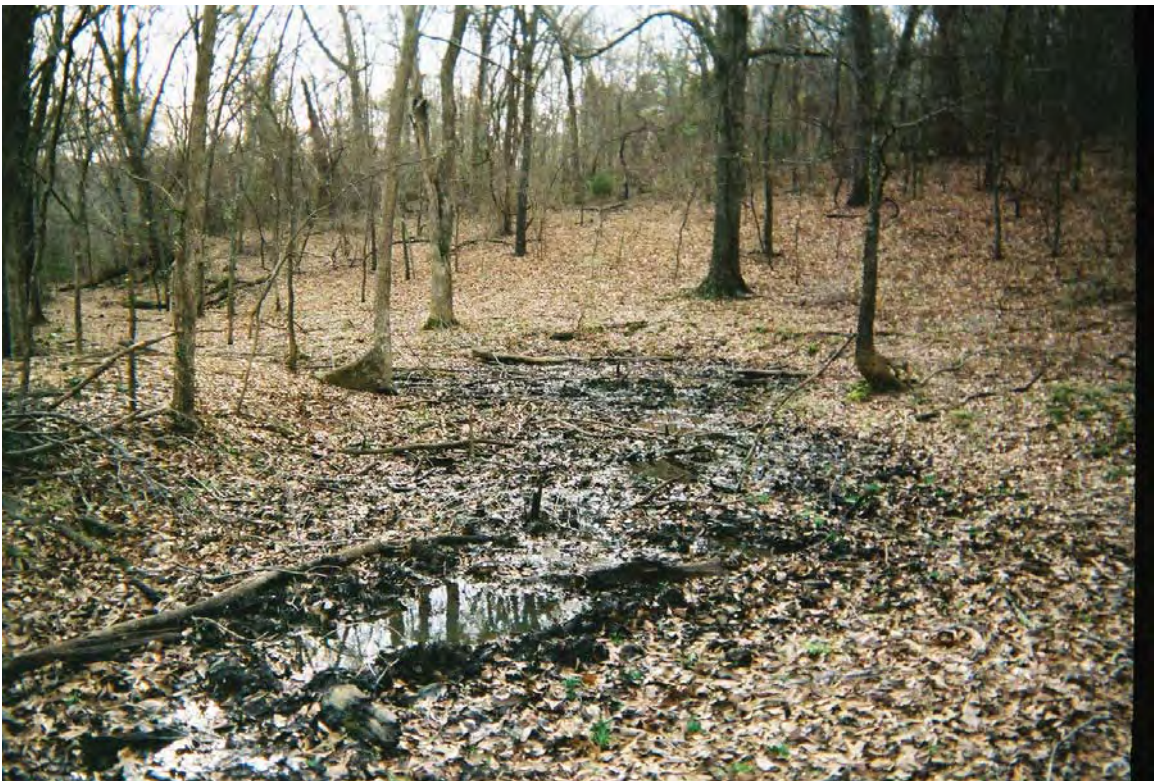
Seep adjacent to wetland in floodplain south of Stevenson Branch, Alternative G.

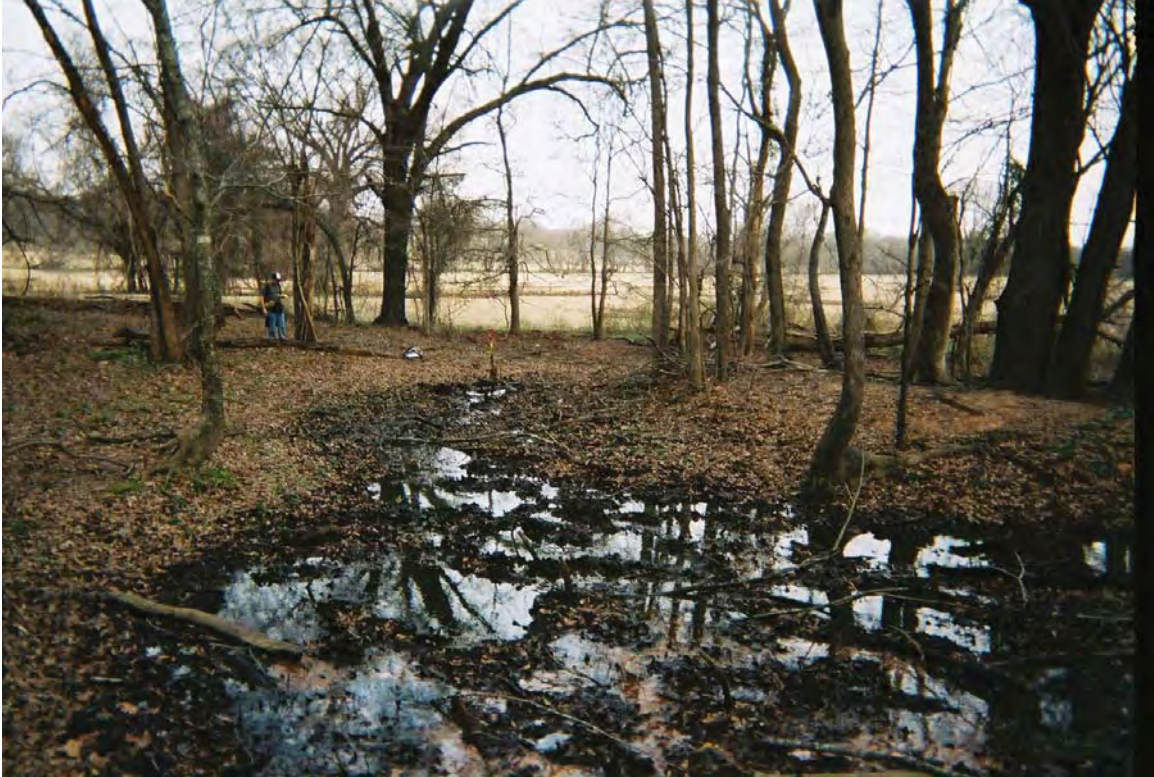
Seep adjacent to wetland in floodplain south of Stevenson Branch, Alternative G.

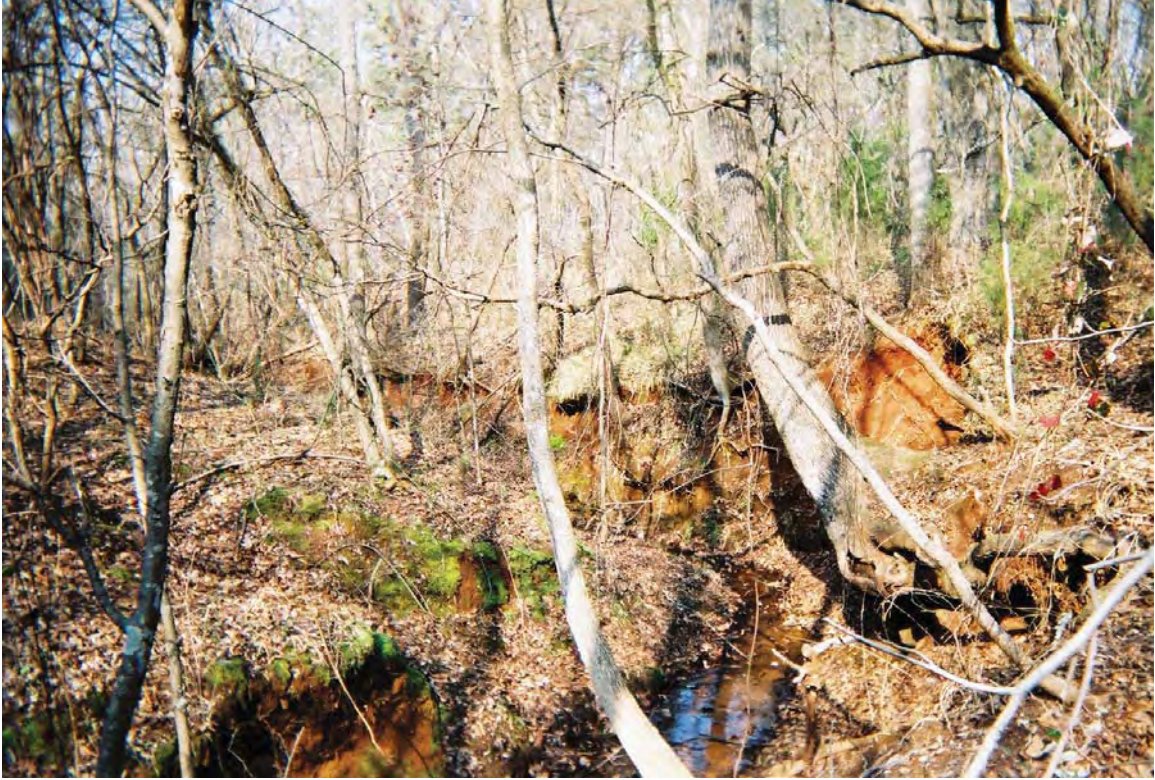
Tributary to Duck Creek, Alternative G.

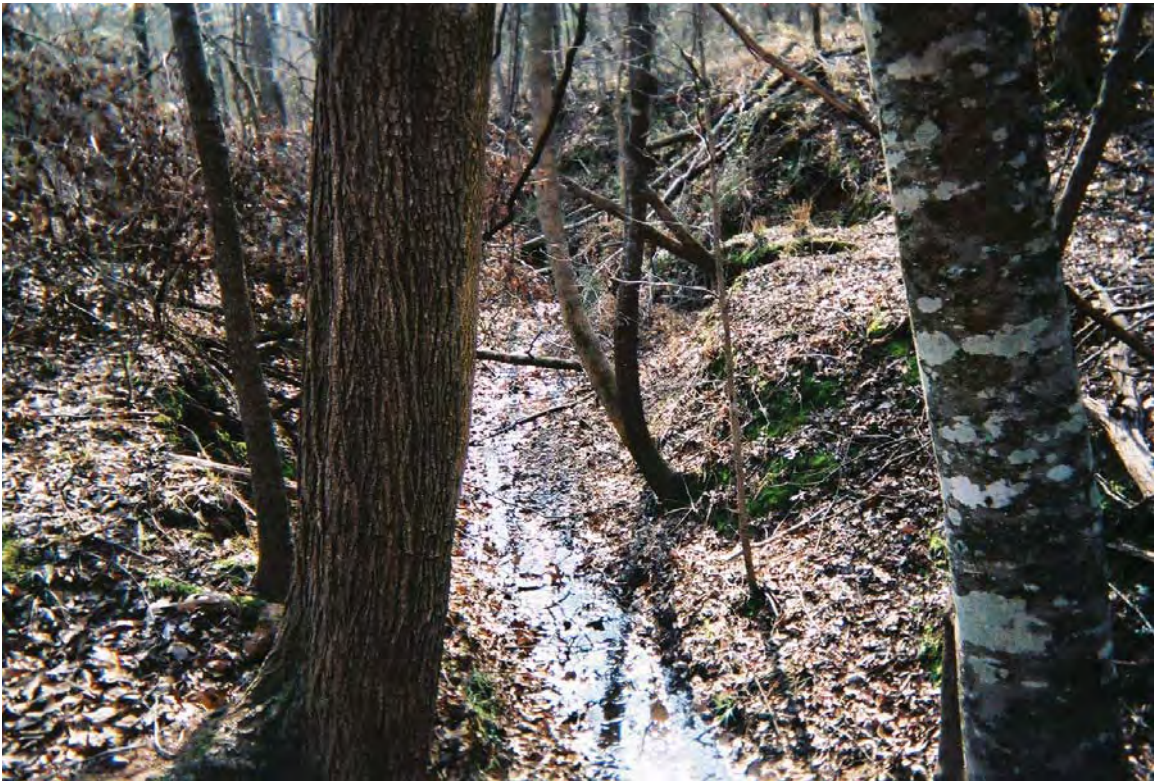
Tributary to Duck Creek, Alternative G.

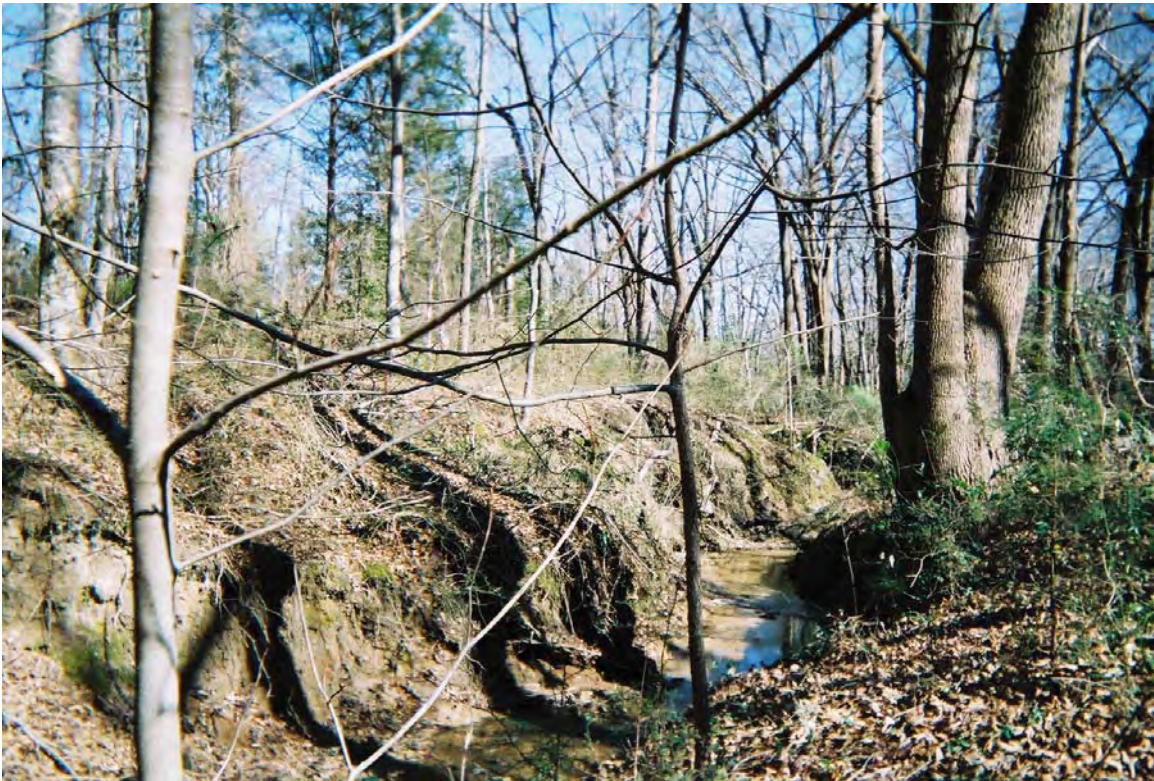
Tributary to Prairie Creek, both alternatives.

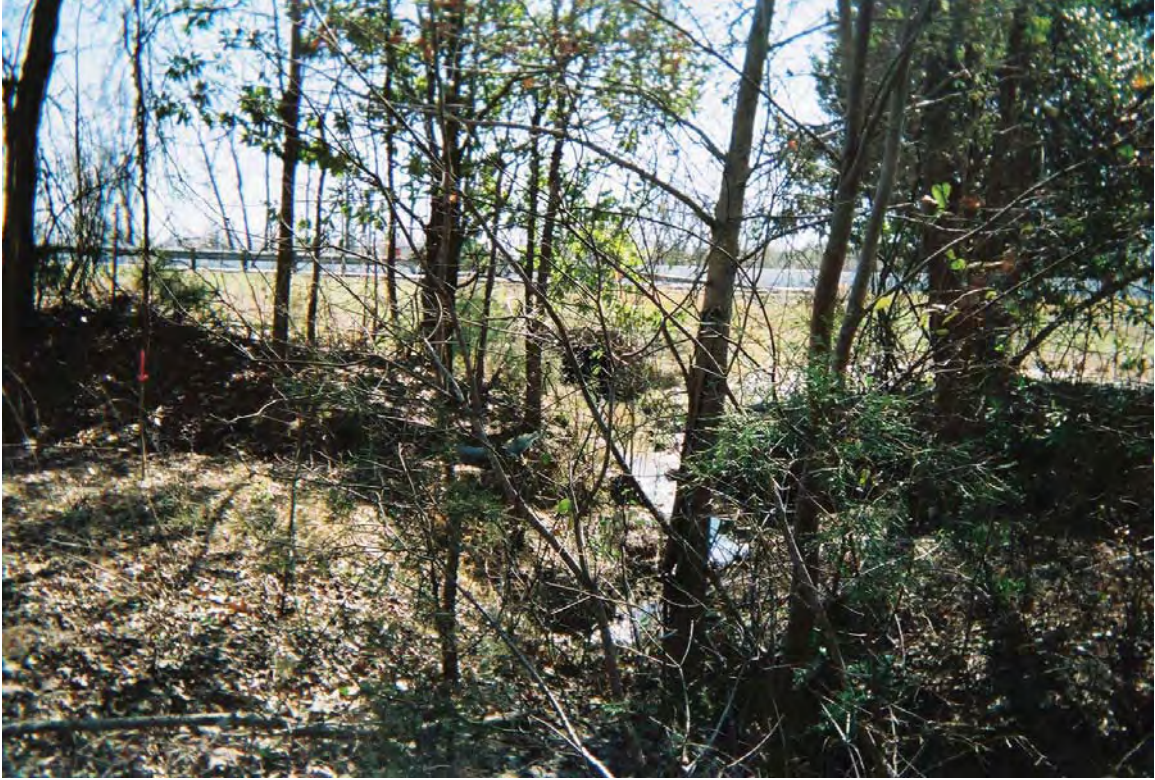
Tributary to Long Brake Creek, both alternatives.

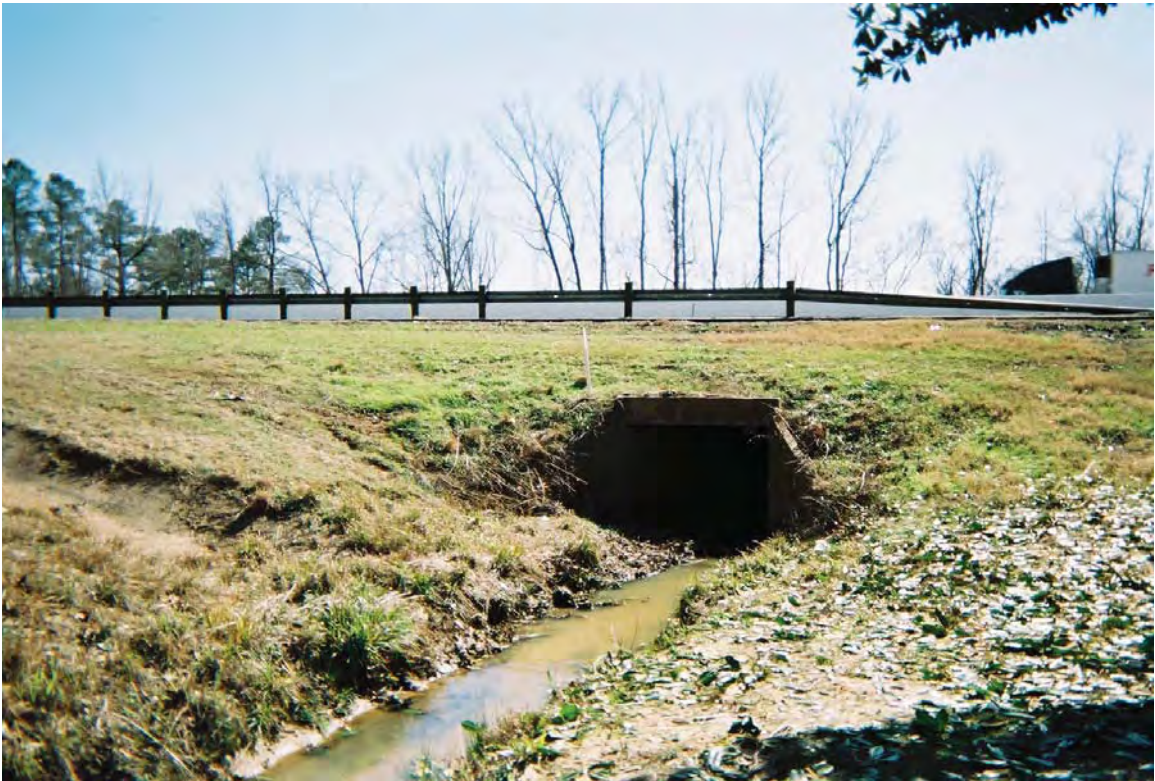
Tributary to Long Brake Creek at IH 20, both alternatives.

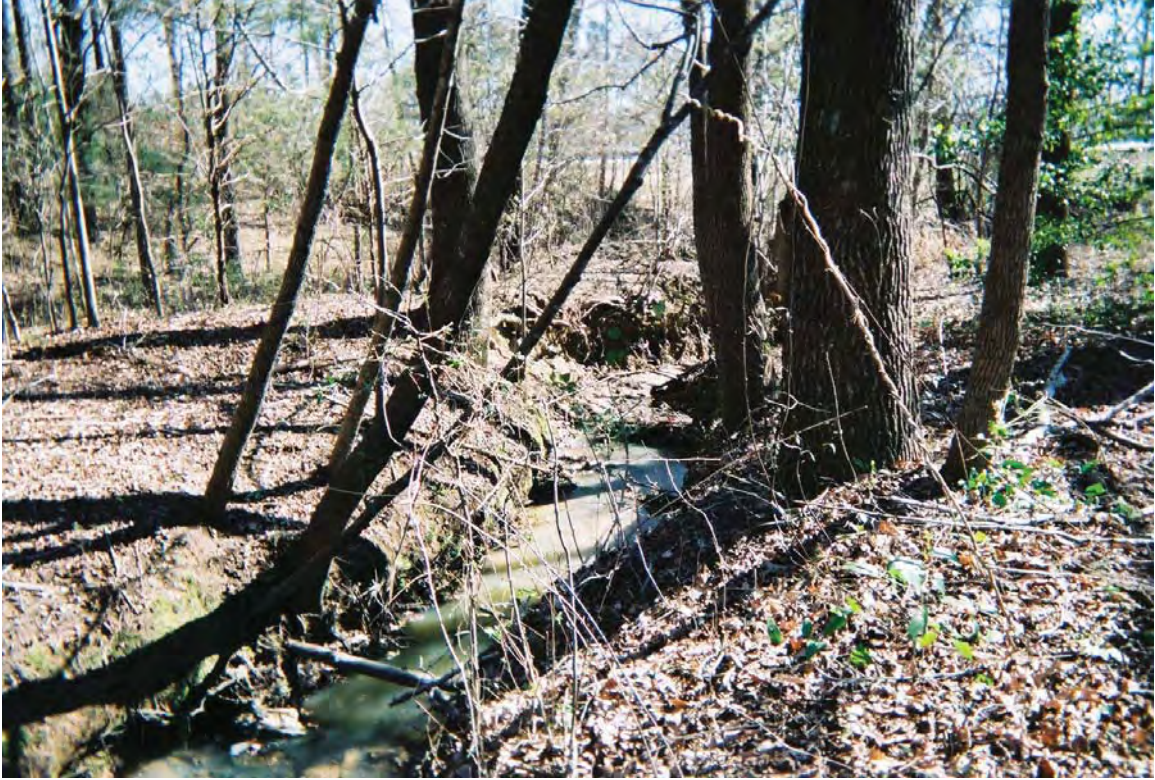
Tributary to Long Brake Creek, both alternatives.

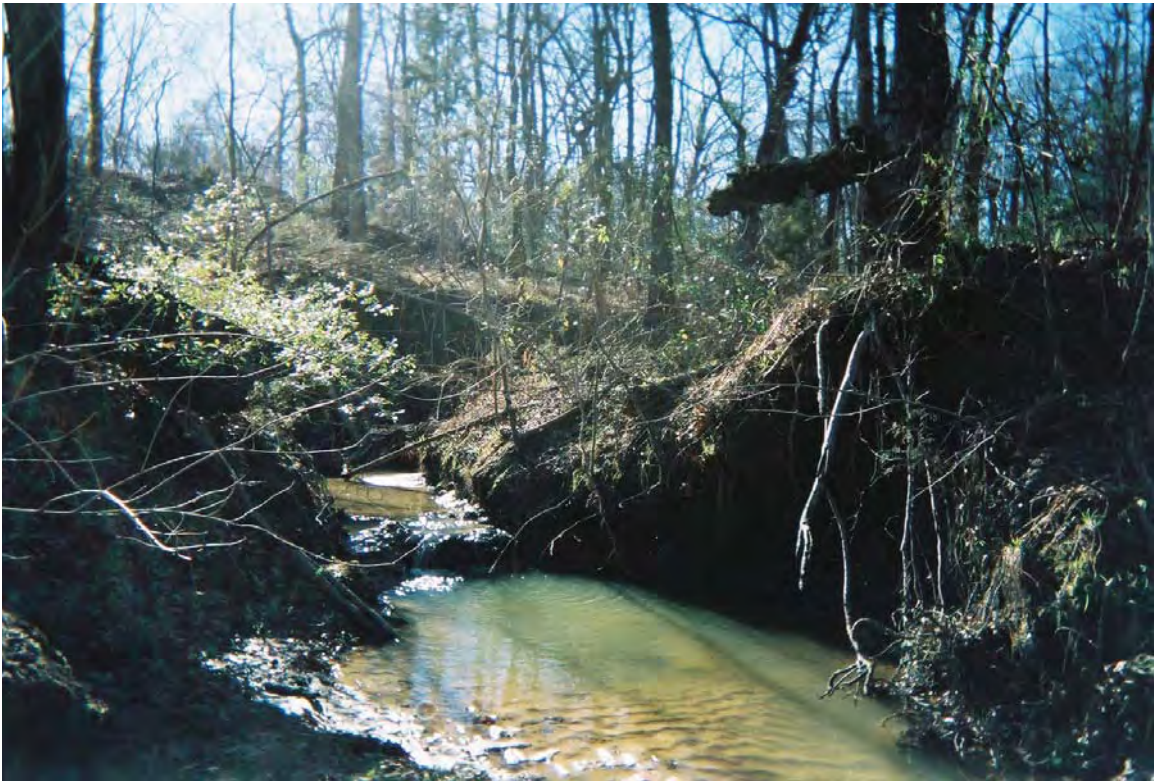
Tributary to Prairie Creek, both alternatives.

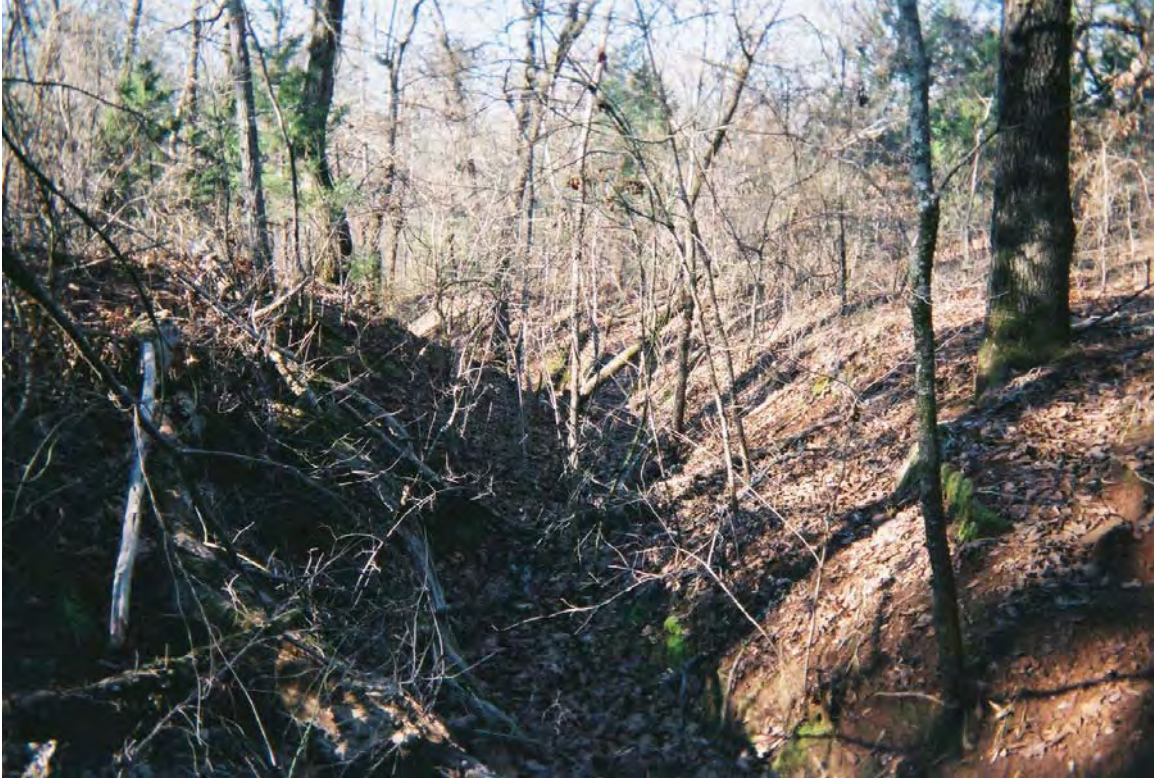
Tributary to Duck Creek, Alternative D.

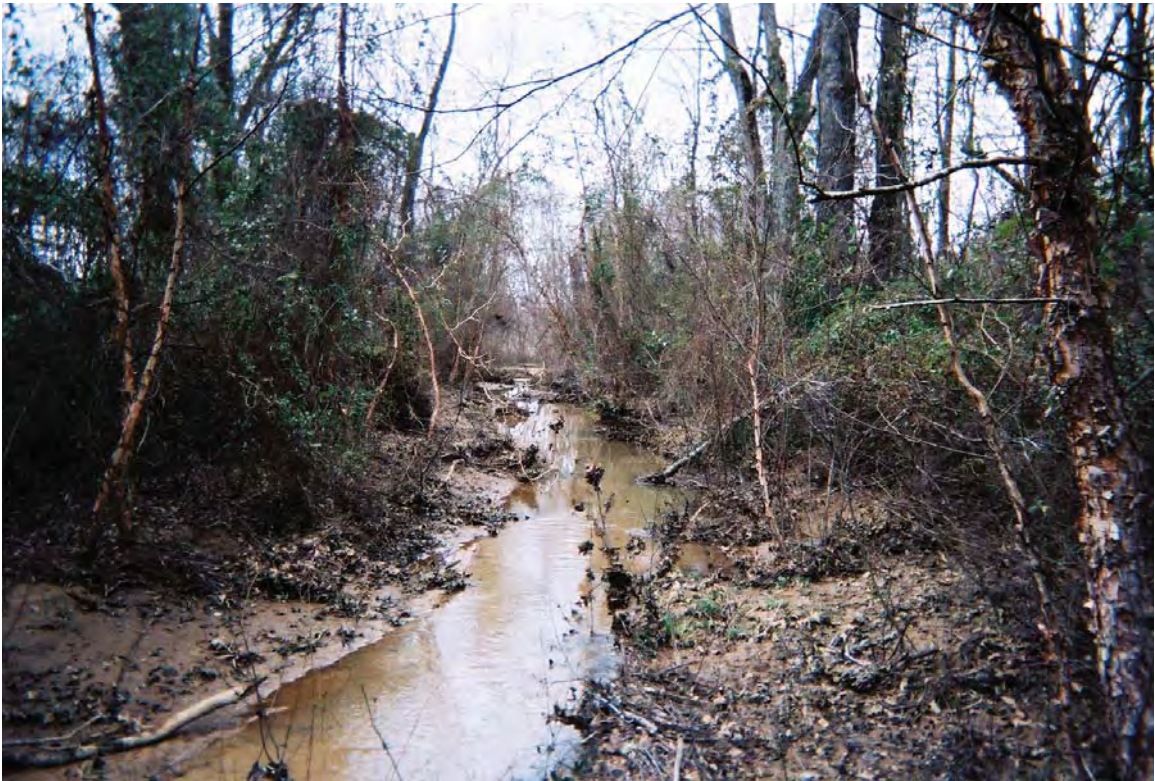
Davis Branch, both alternatives.
